Case 301 : Narrative

Case Vehicle (A): 2000 Mercury	Vehicle (B): 1994 Oldsmobile
Type: Cougar, 2-door coupe	Type: Bravada MPV, 4-door
Driver: 45-year-old female	Driver: 43-year-old female
CDC: 12-FDAW-6	CDC: 12-FDEW-4, 00-RDAO-2

This is a fatal crash. Both drivers sustained fatal injuries in this severe head-on impact.

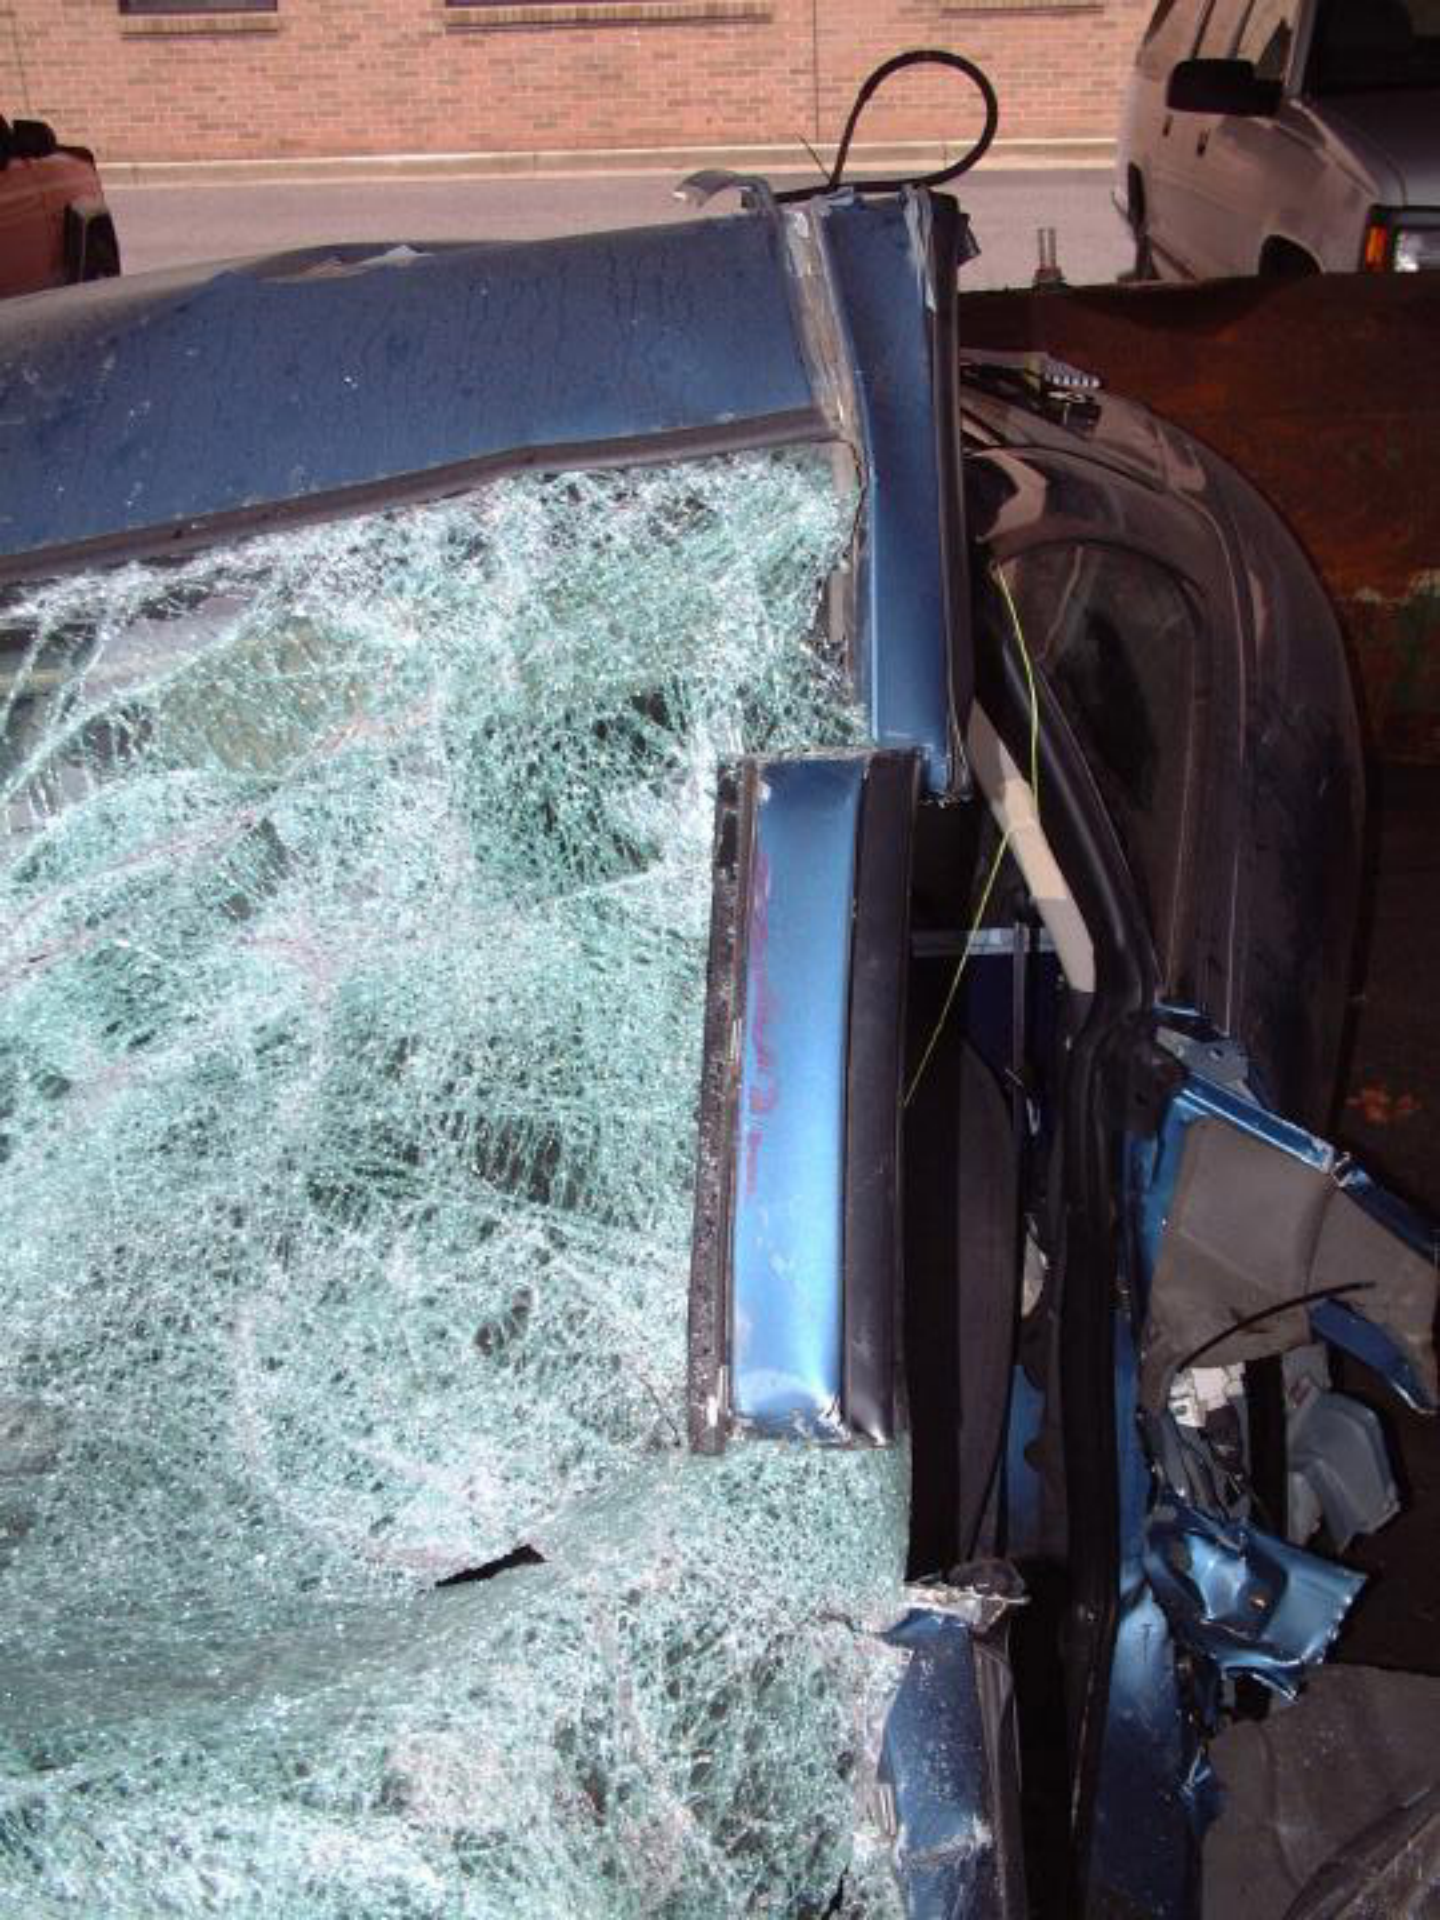
[30](#) On the left side, the front fender was crushed rearward into the left-front wheel, which was damaged and pushed rearward. The front axle was broken, and the left wheelbase was reduced 56 cm. [31](#) The upper portion of the left A-pillar was moved rearward and

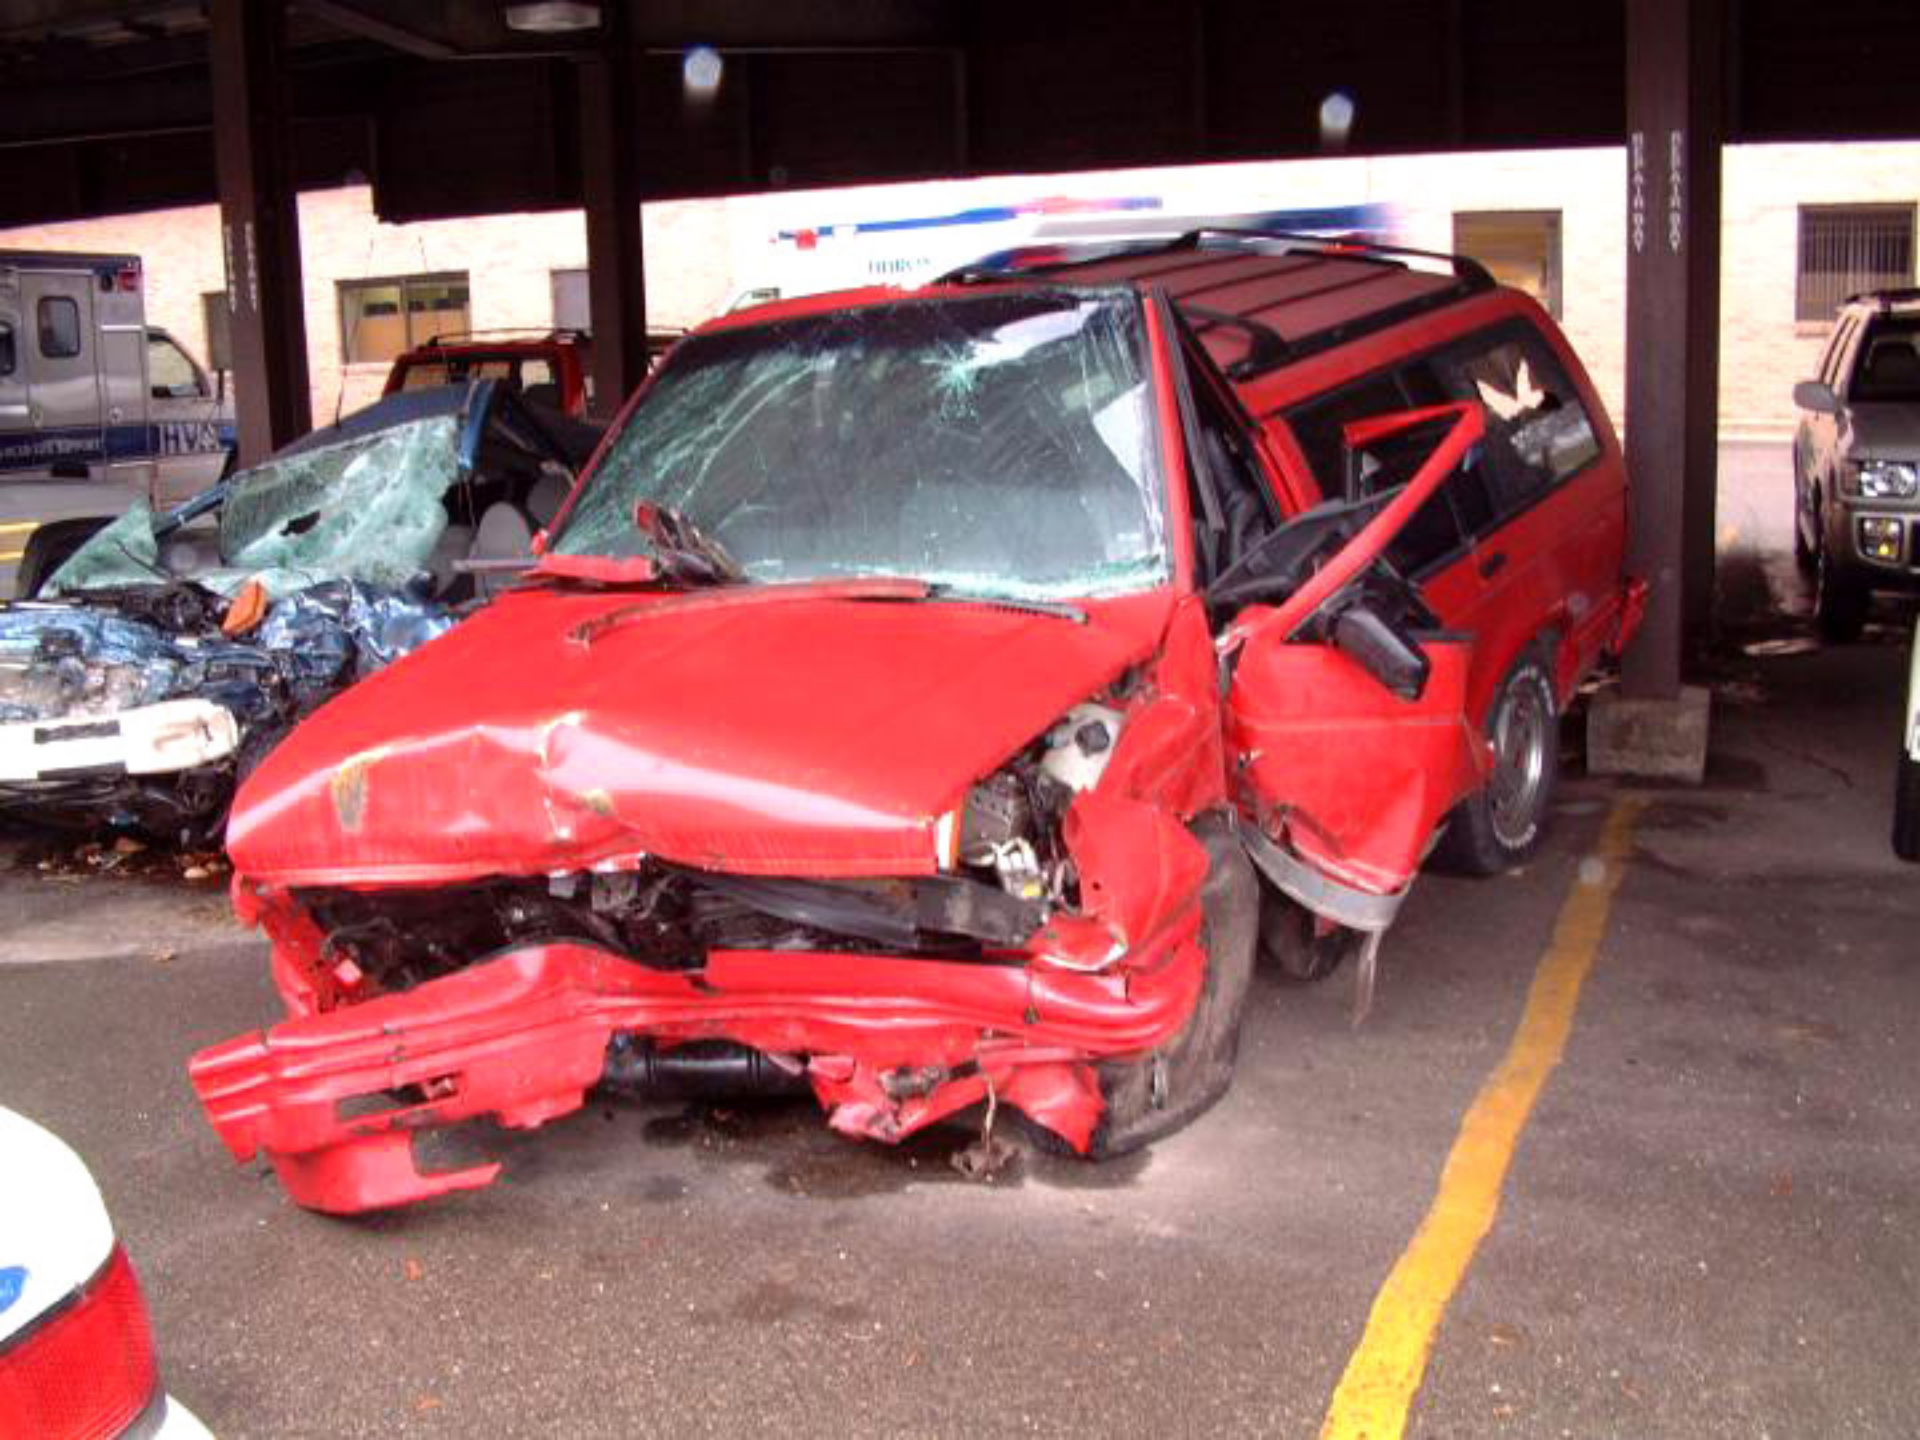
stood up almost vertical, and it had been cut during extrication of the driver. [32](#) Also, the damaged and jammed driver door had been pried open by the rescue personnel, and the window glass was broken. [33](#) The lower portion of the A-pillar and the upper and lower portions of the B-pillars were also damaged. [34](#) The left-rear quarter panel was slightly buckled just behind the driver door, but there was no other damage to the left side and no damage to the upper portion of the C-pillar. [35](#) There was no damage to the rear of case vehicle (A).

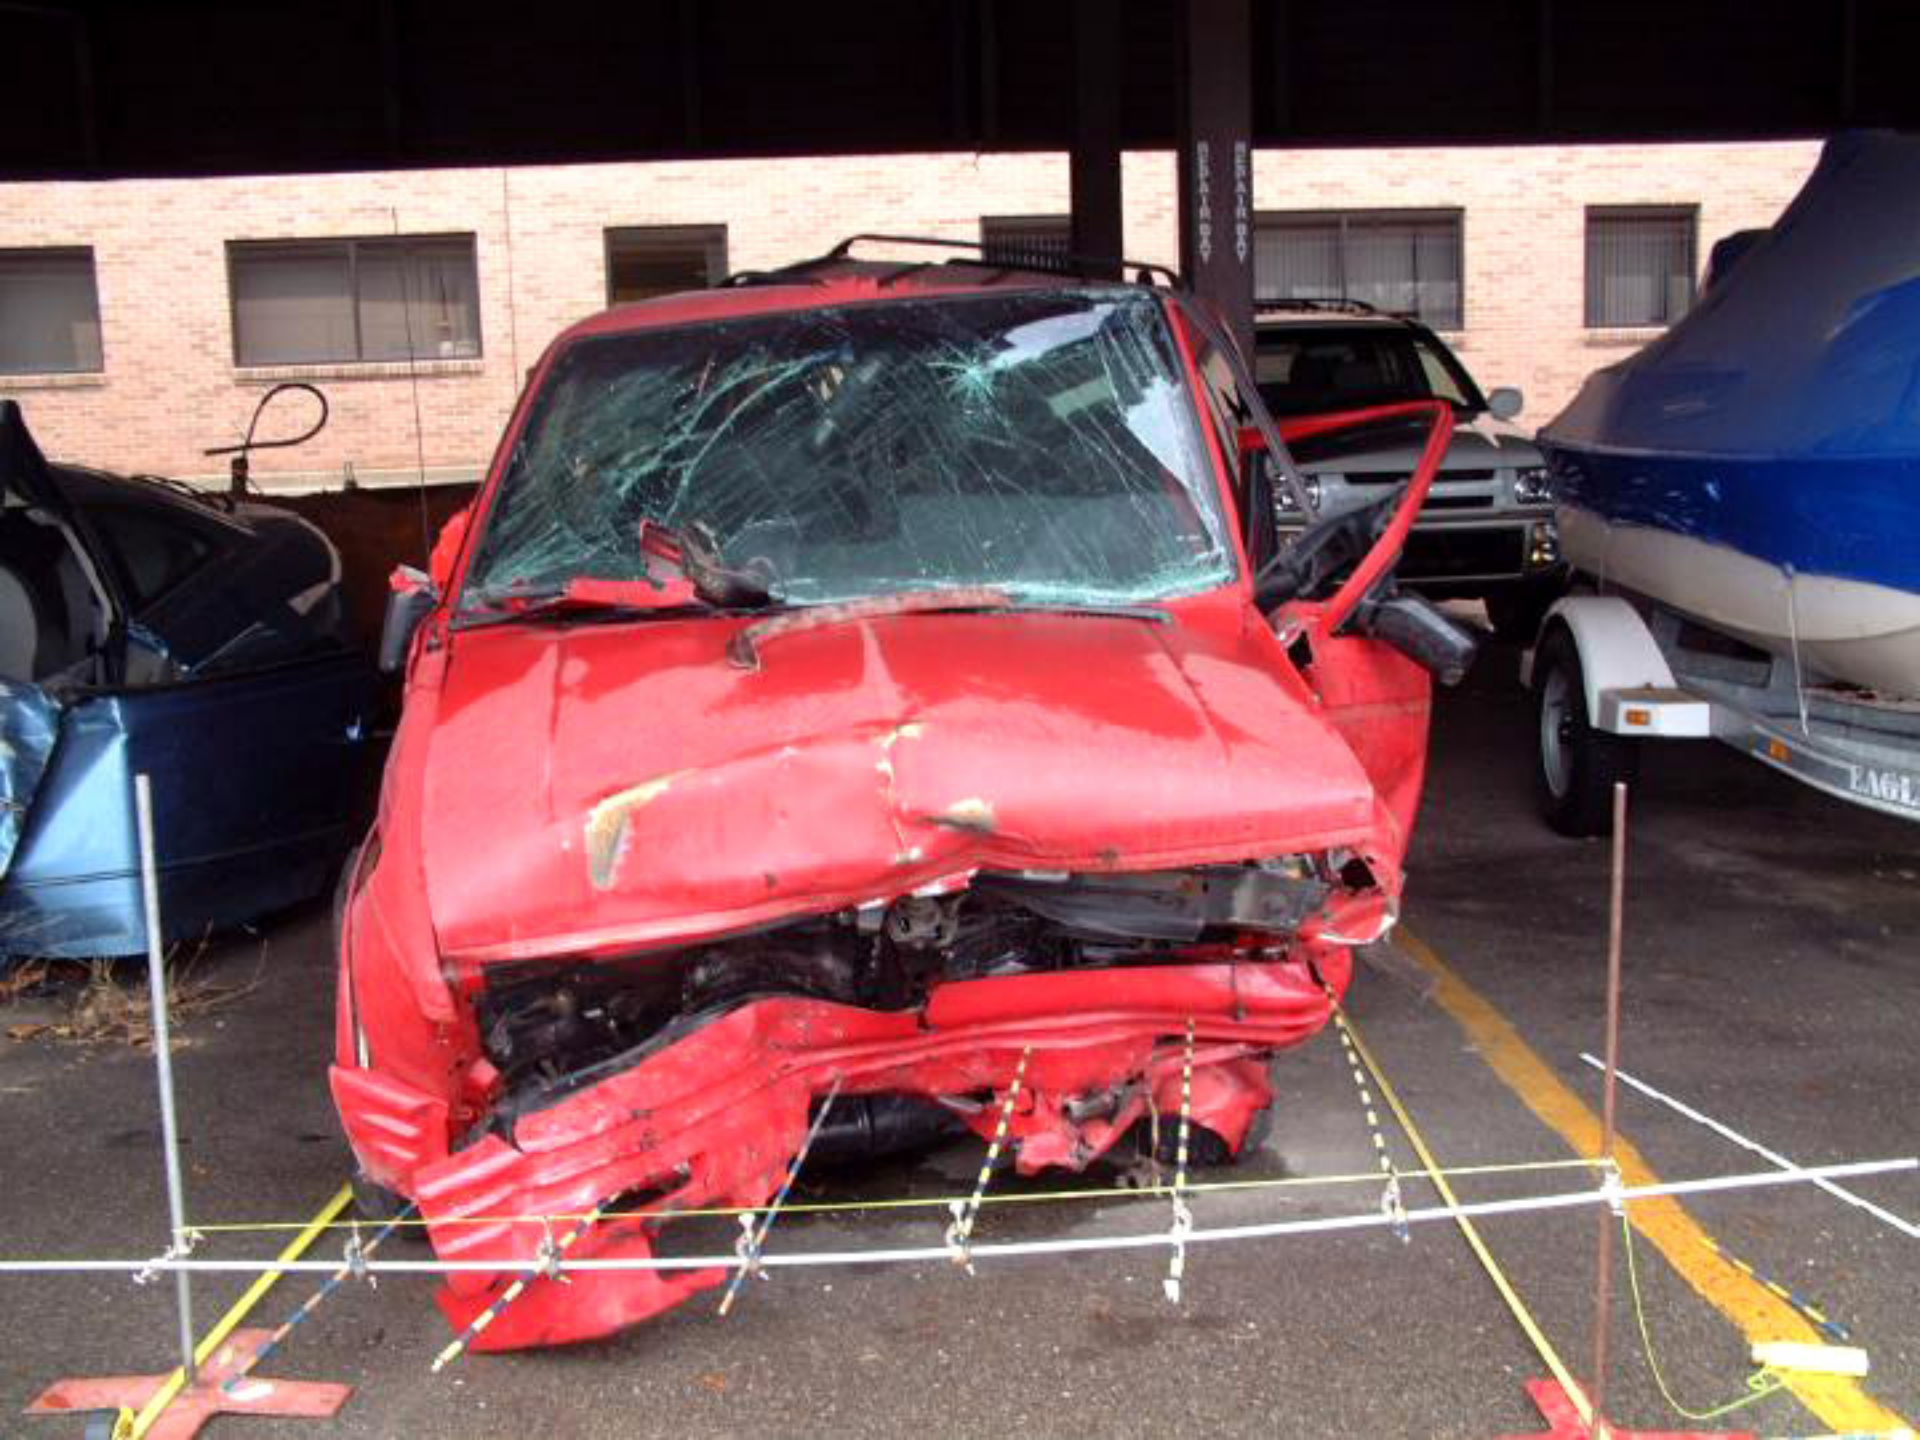
[36](#) The right fender was deformed and shifted to the left. [37](#) The upper and lower portions of the A-pillar were displaced and the right door was jammed closed. [38](#) There was no damage to the right wheels, although the wheelbase was increased 4 cm. There was no damage to the right B-or C-pillars, and the quarter panel was buckled just behind the right-front door.

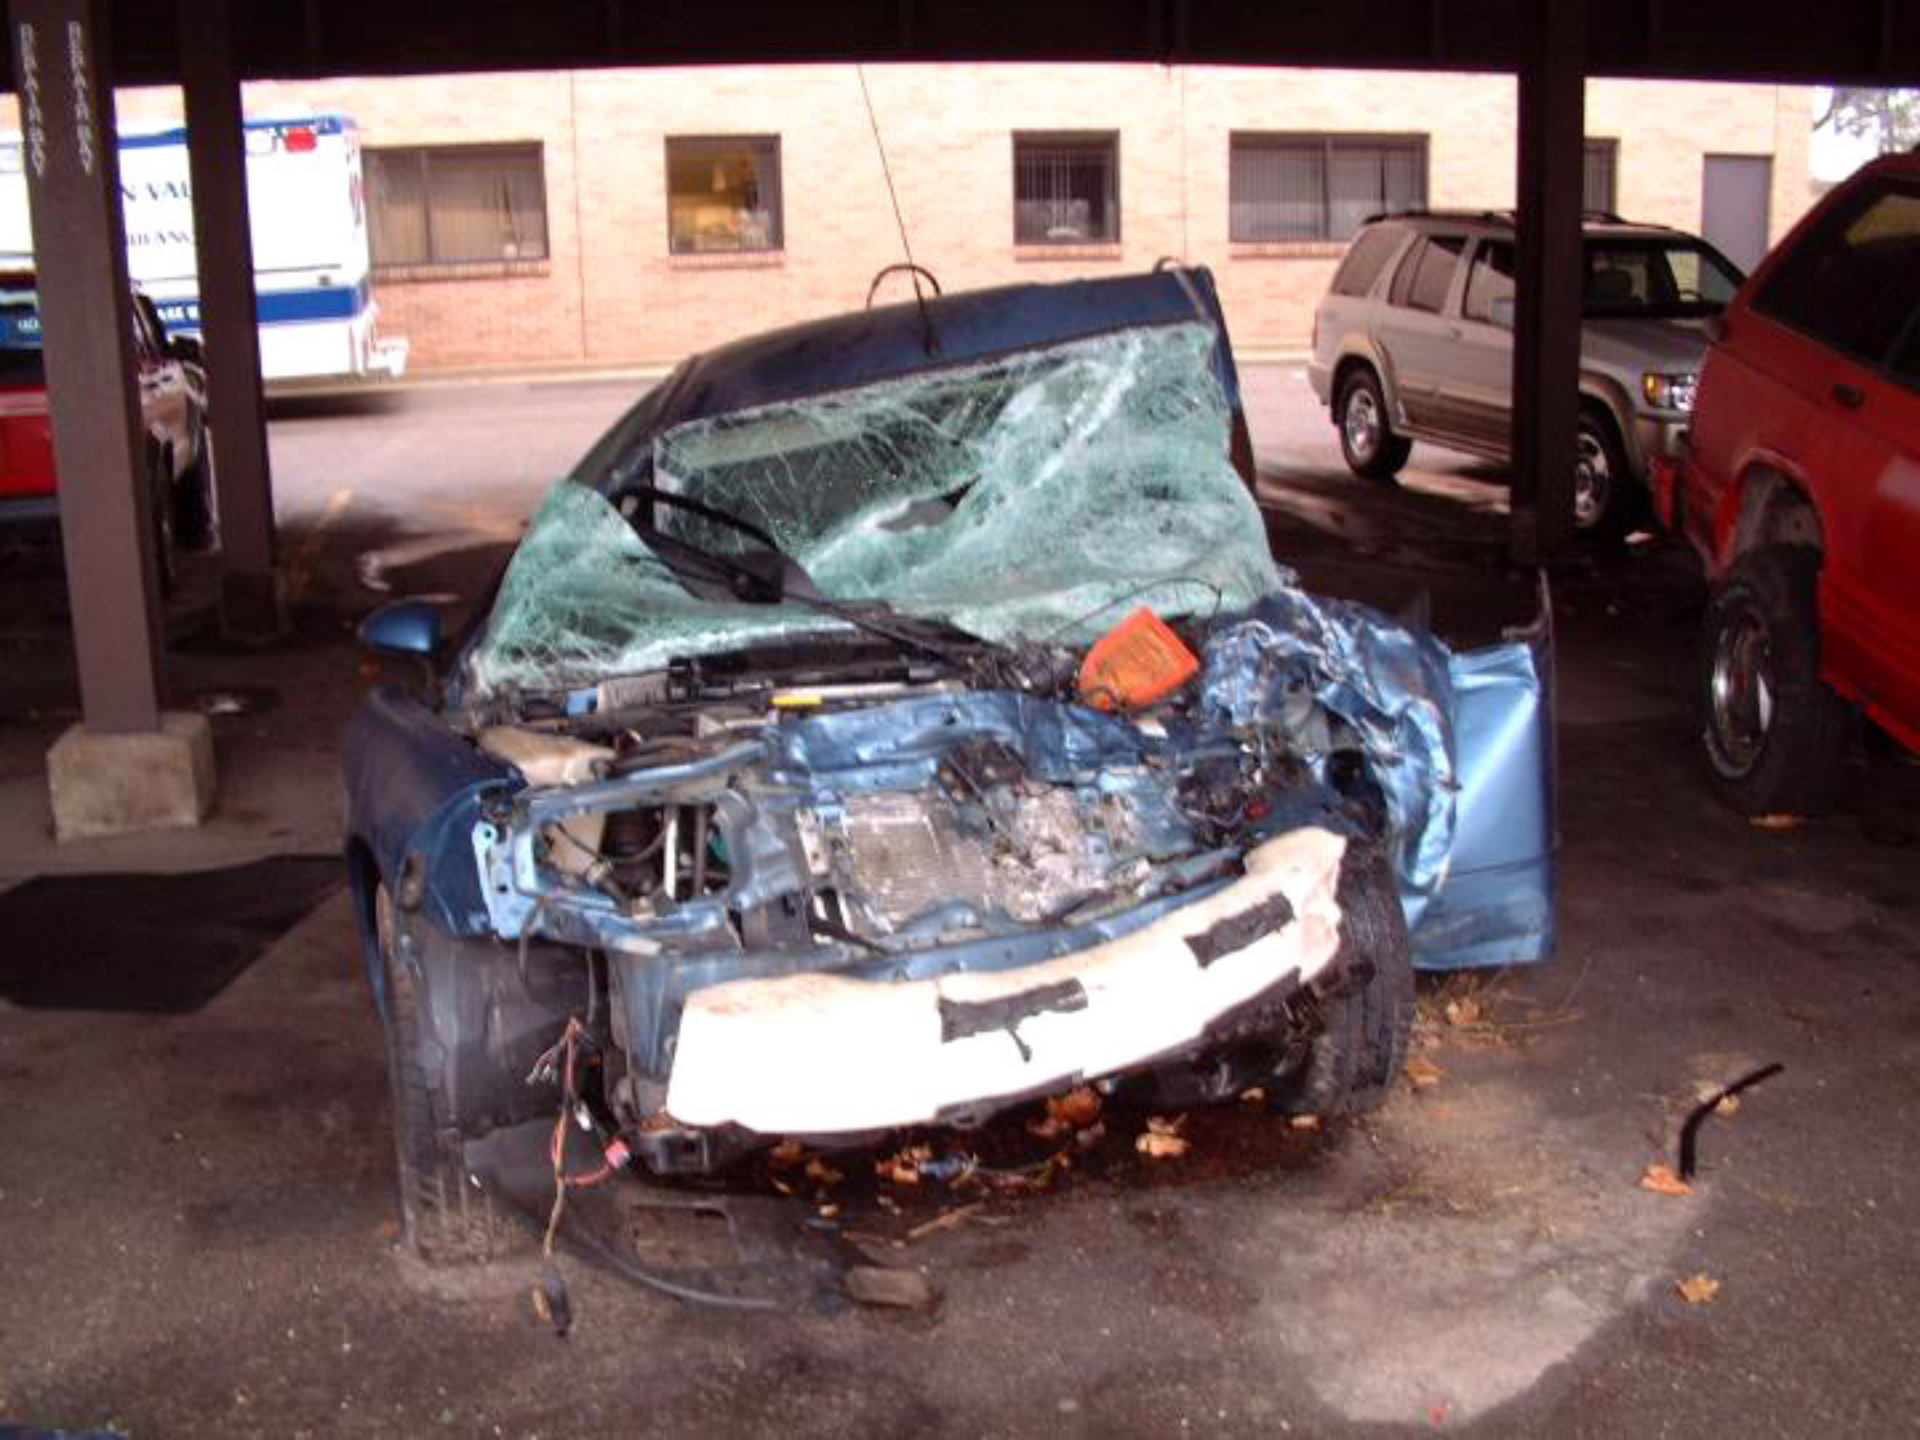
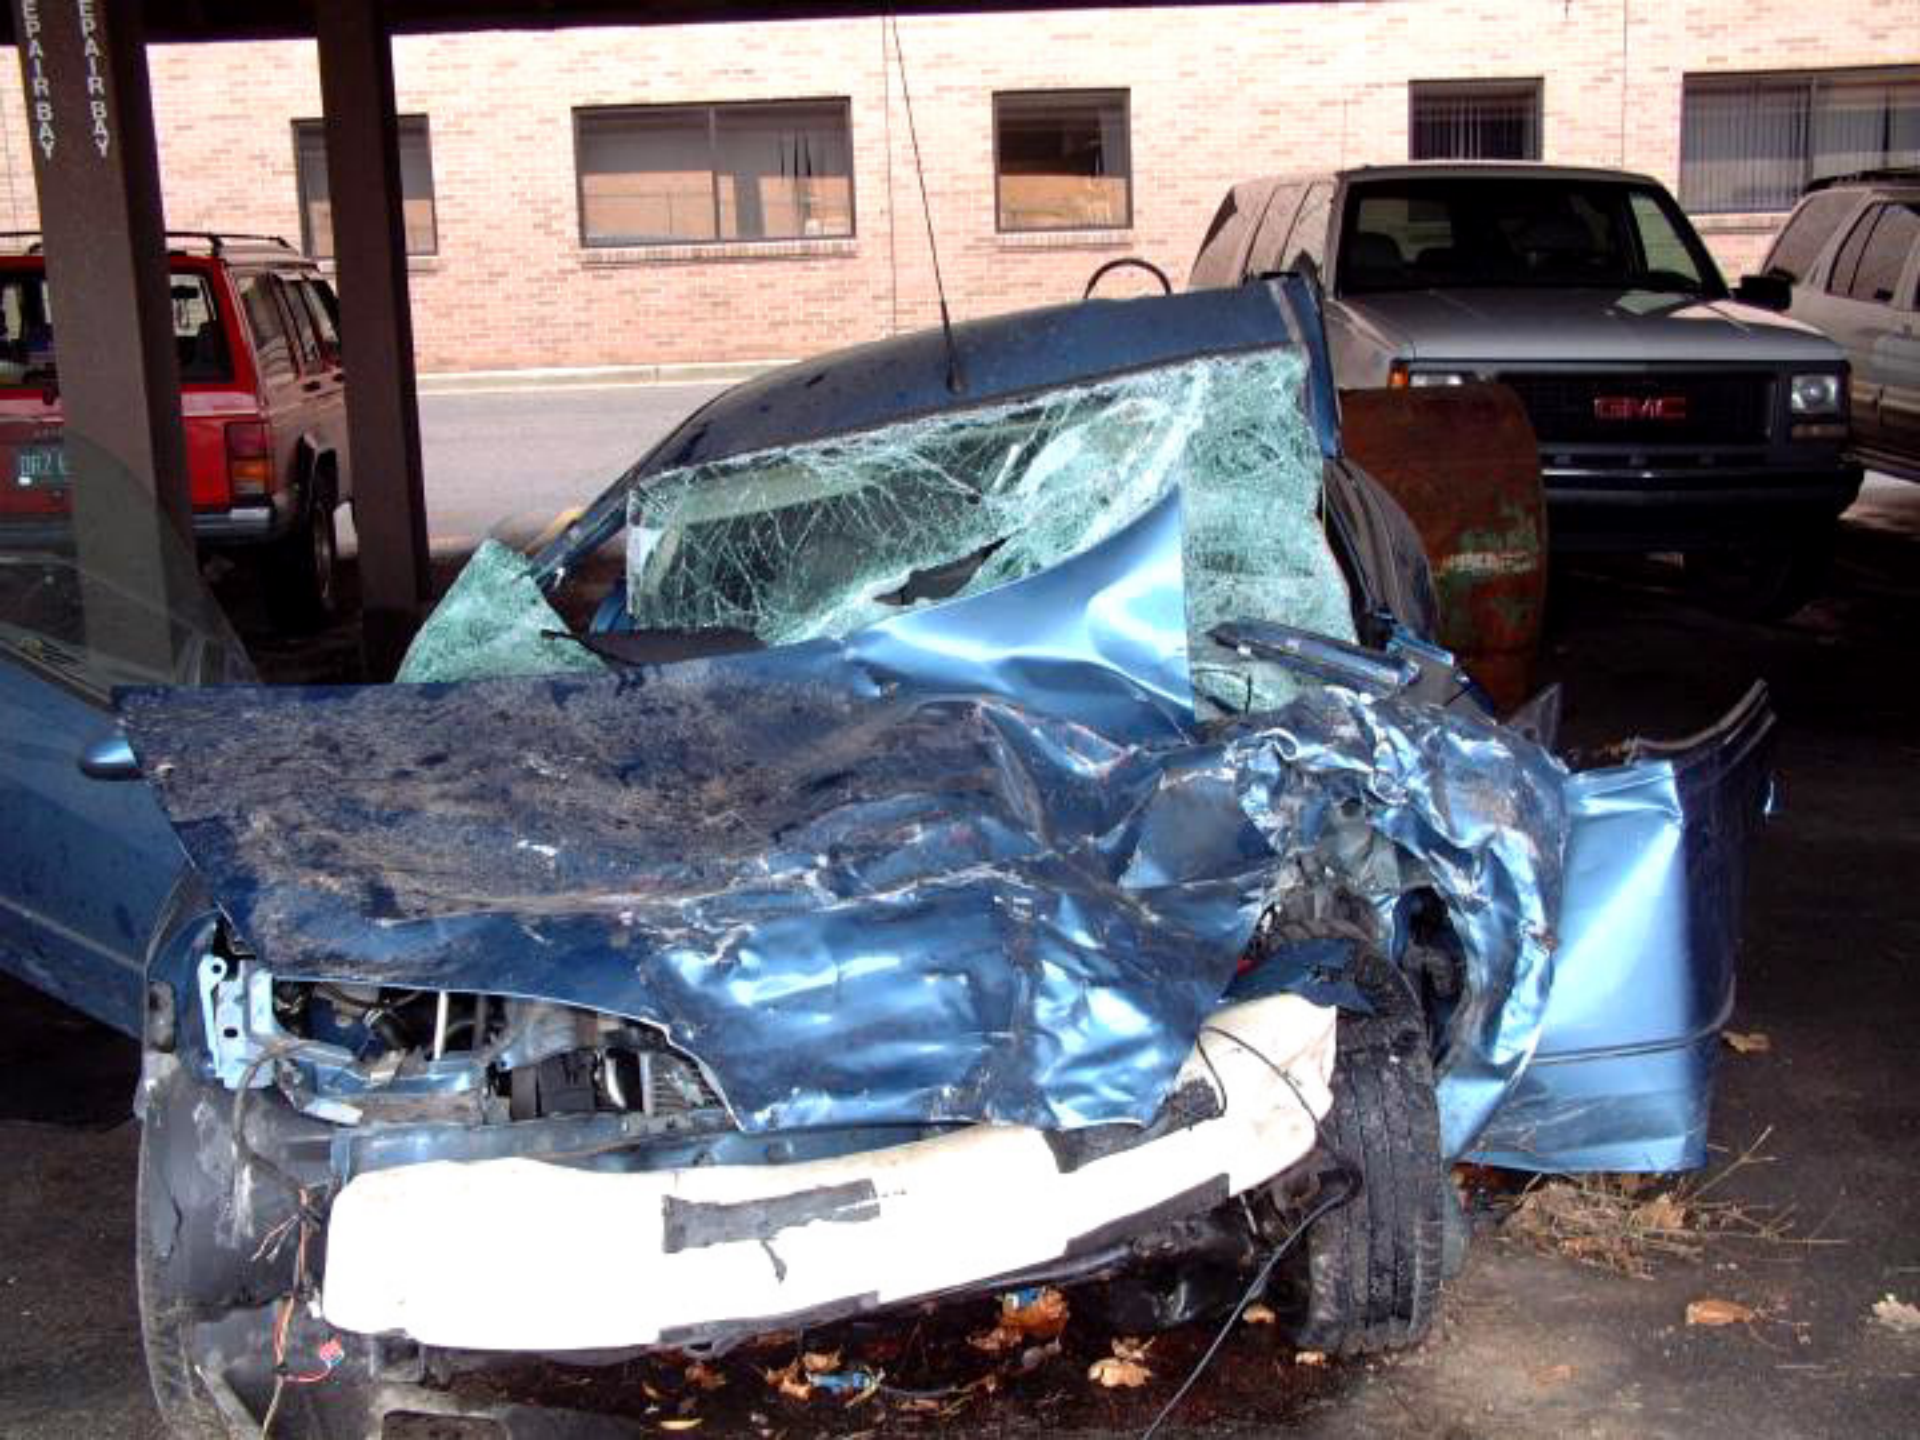
[39](#) [40](#) This vehicle is equipped with steering-wheel and passenger frontal-impact airbags, which deployed during this severe frontal impact. [41](#) [42](#) The driver airbag and the passenger airbag skins had small cuts in the back side of the fabric, probably from broken windshield glass. [43](#) There were no contact marks on the driver airbag. [44](#) Rescue personnel removed the steering-wheel rim/hub and much of the steering column during extrication, so rotation of the steering column could not be determined. [45](#) [46](#) [47](#) [48](#) [49](#) The steering-wheel hub was damaged, the steering-wheel rim was severely bent in a concave manner, and the steering-wheel spokes were damaged, probably due to loading by the unbelted driver through the airbag. [50](#) [51](#) Also in the driver area, the left-front door, the door hardware, and the door armrest appeared to be damaged from the crash, but were also damaged during the driver extrication. [52](#) [53](#) The toe pan, floor area, and the foot controls in the driver area were also damaged and displaced to the rear. [54](#) [55](#) The driver seatback and seat cushion were damaged, the seat adjuster was jammed, and the seatback was rotated forward. [56](#) [57](#) [58](#) The upper and mid portions of the instrument panel in the driver area were displaced and damaged, and the driver knee bolster was damaged. [59](#) [60](#) All components on the instrument panel and dashboard were damaged,

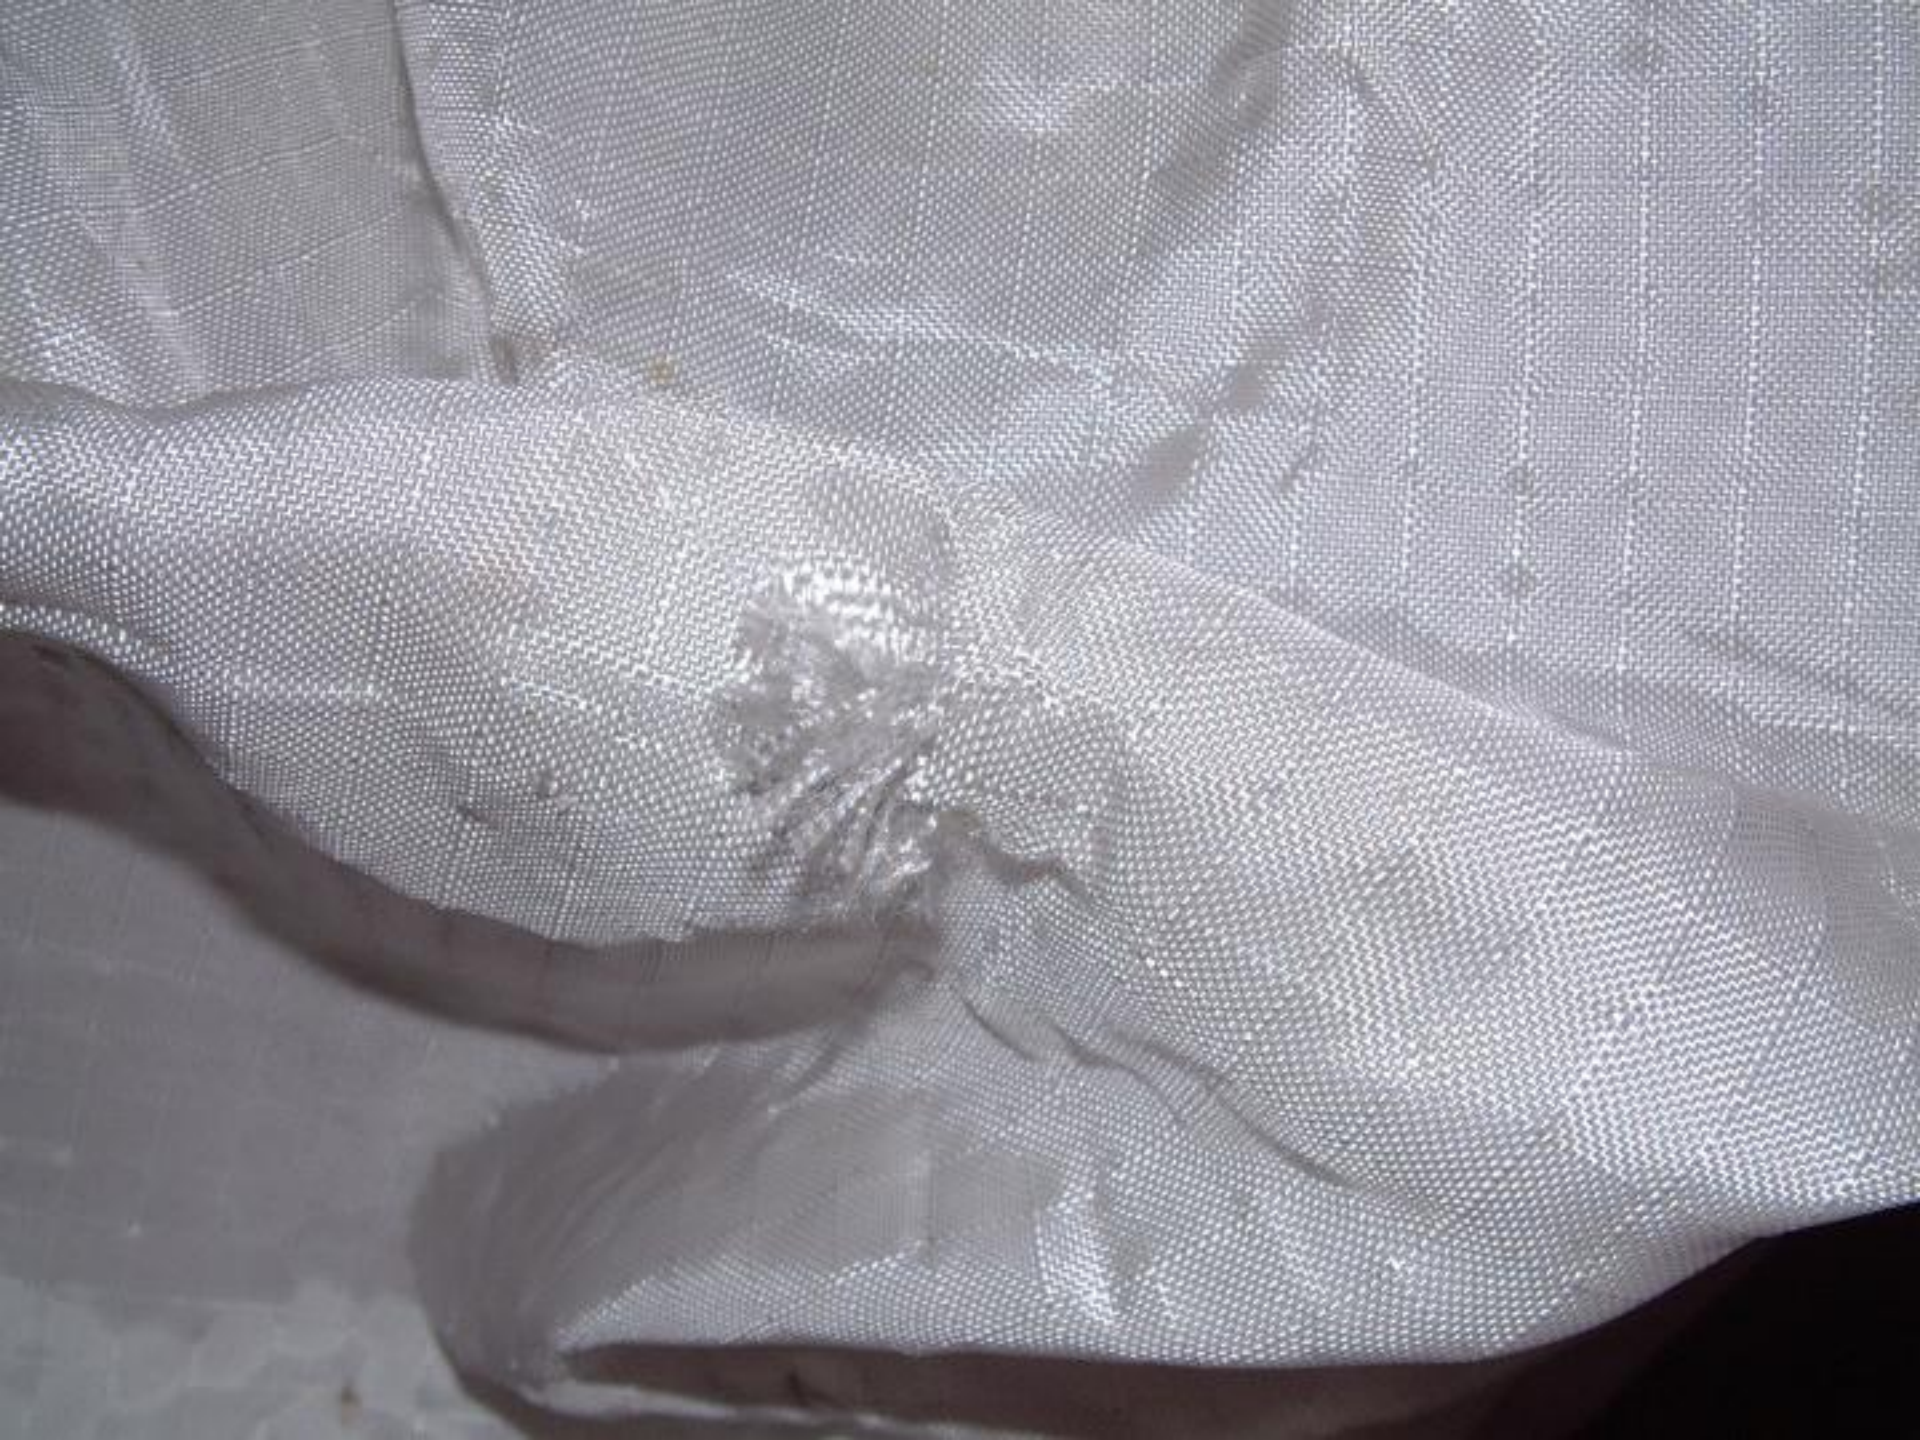
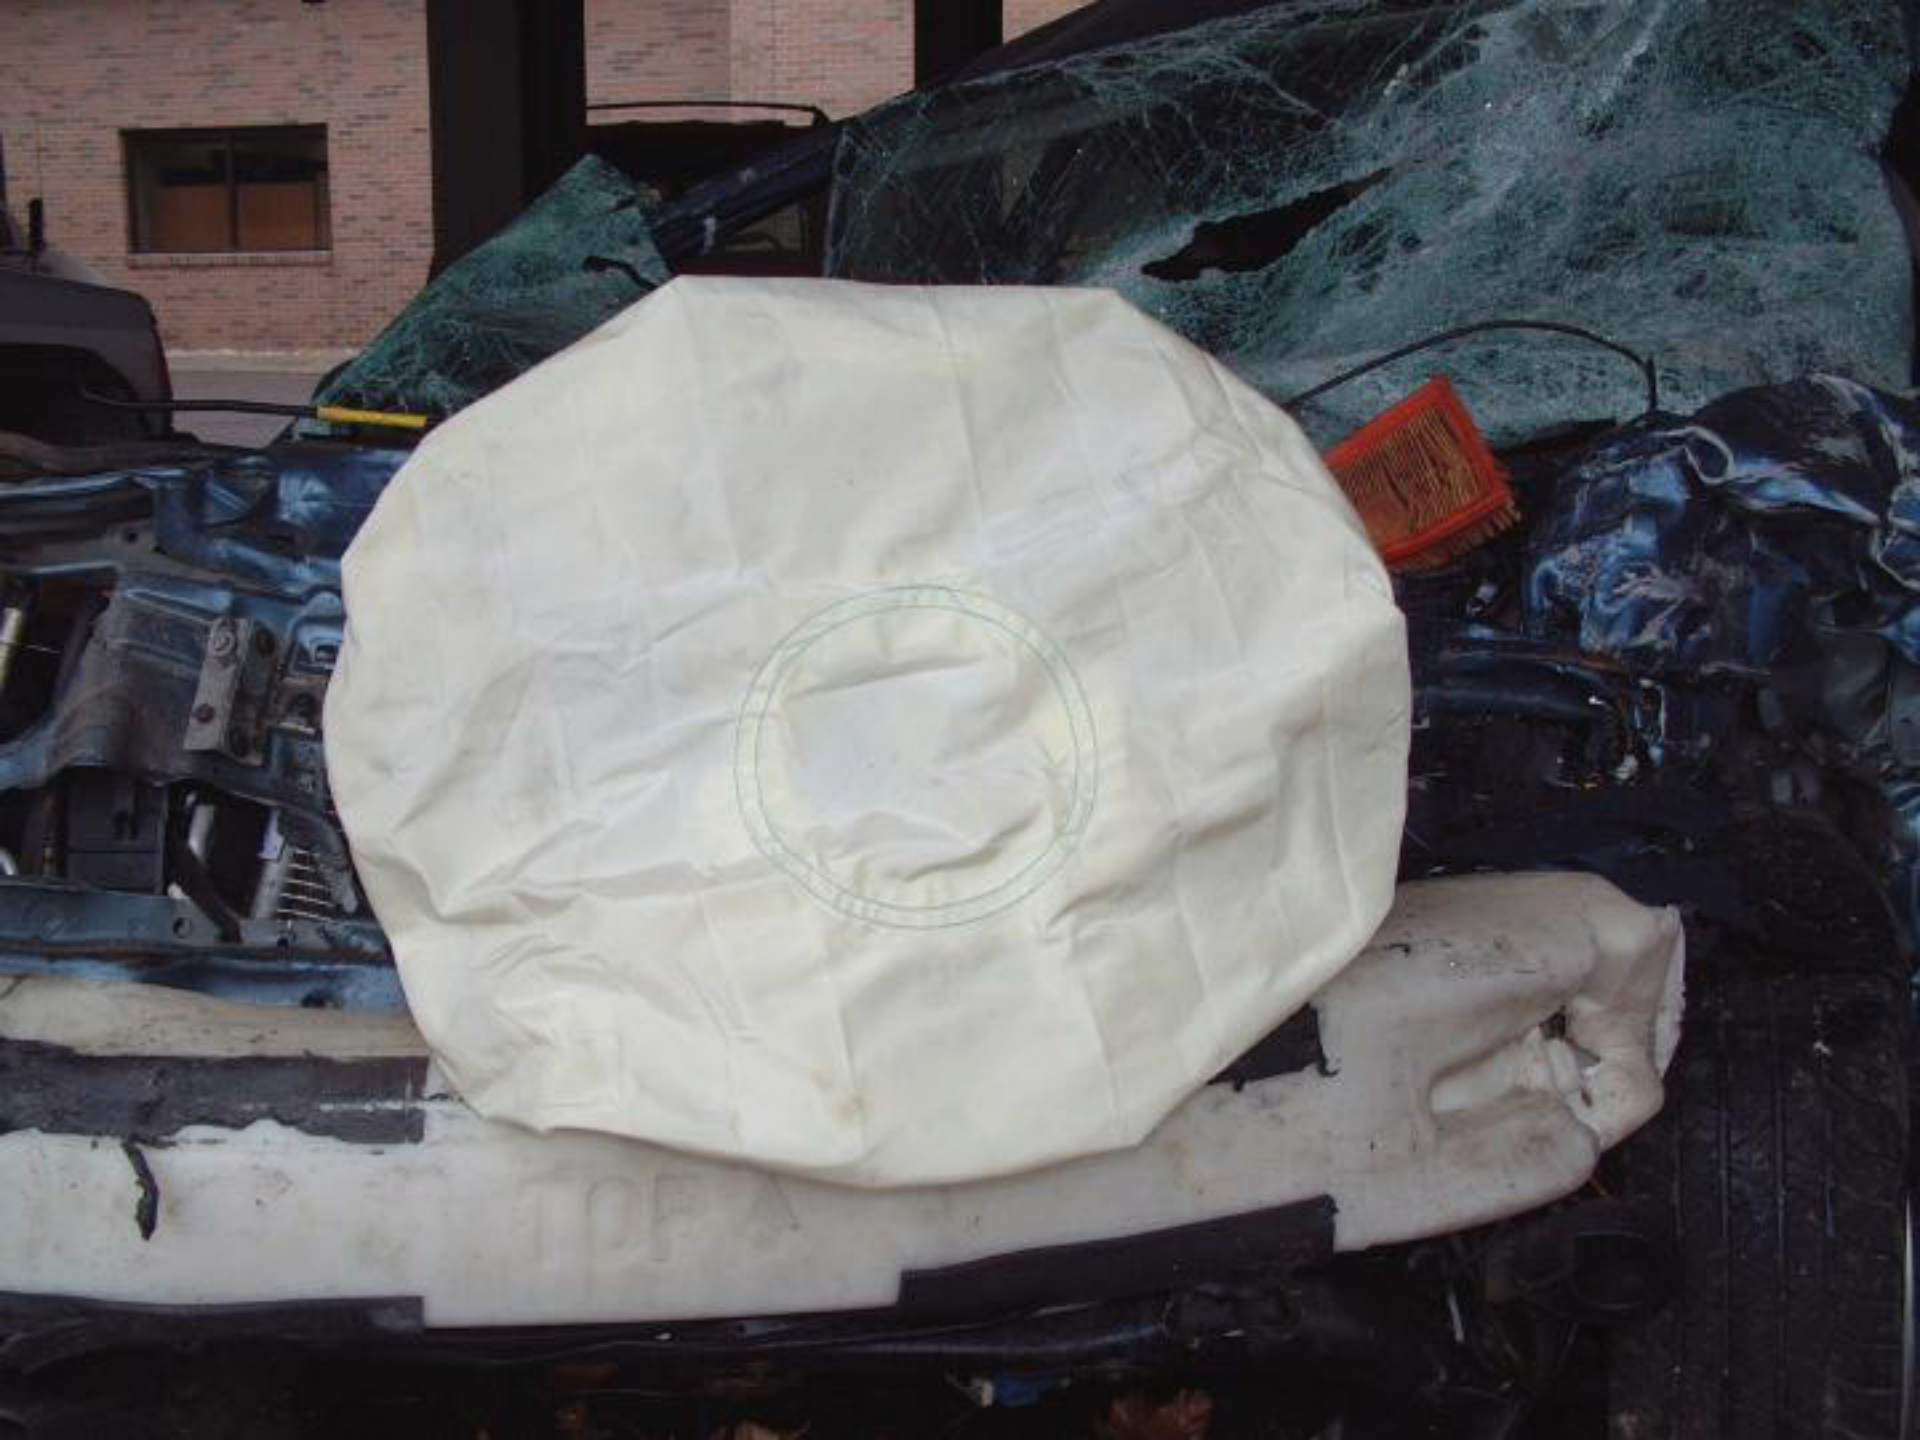
including the ashtray, control knobs, instruments, glove compartment, vents, ducts, and the radio. [61](#) [62](#) [63](#) The interior of the windshield was damaged throughout, the windshield header was displaced to the rear, and the interior areas of both A-pillars were damaged. Also, the roof interior and roof headlining were deformed. [64](#) The right-front seatback was deformed and rotated forward, and the seat adjuster was jammed. [65](#) [66](#) [67](#) The following intrusions were noted and measured:
